Chicago Committee on High Rise Buildings

## Seminar on Recladding of the Amoco Building in Chicago, Illinois

November 1995  
Report No. 15

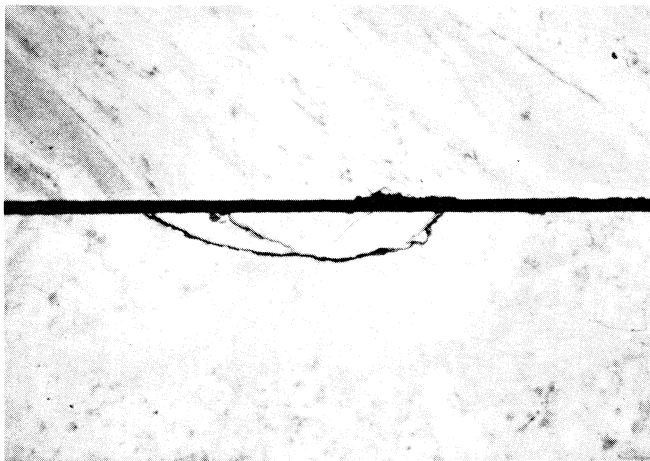
1. Crescent shaped cracks in approximately 230 marble panels at connections, as typically shown in Fig. 3-2. As Roger had previously described, the panels were laterally supported at their horizontal joints by the two, 6 in. long upturned and downturned tabs of the stainless steel shelf angle that were inserted into kerfs cut in the top and bottom of the panels. The observed crescent shaped cracks occurred in the panels at these lateral connection points.

**Fig. 3-2 - View of typical crescent shaped crack in marble panel at connection.**

After the 1979 inspection was completed, Amoco removed all of the seven panels with outward displacement, repaired the cracks in the panels, and continued to inspect and maintain the marble panels on the building.

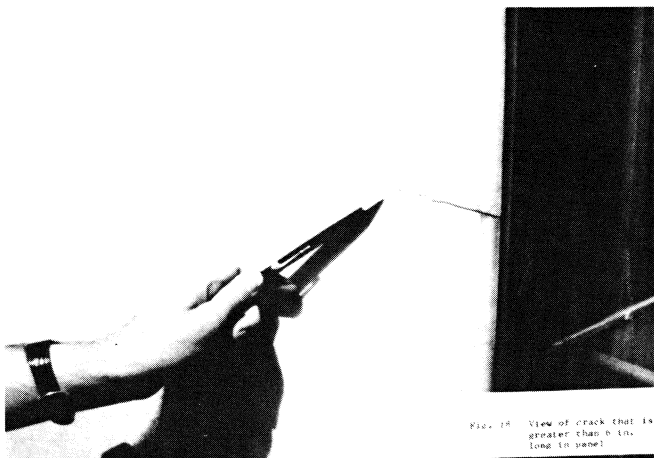
FIG. 3-3 View of crack that is greater than 6 in. long (in panel)

2. Vertical, horizontal and/or diagonal cracks away from connections in approximately 1,800 marble panels, as typically shown in Fig. 3-3.

Fig. 3-3 - View of diagonal crack in marble panel away from connections.

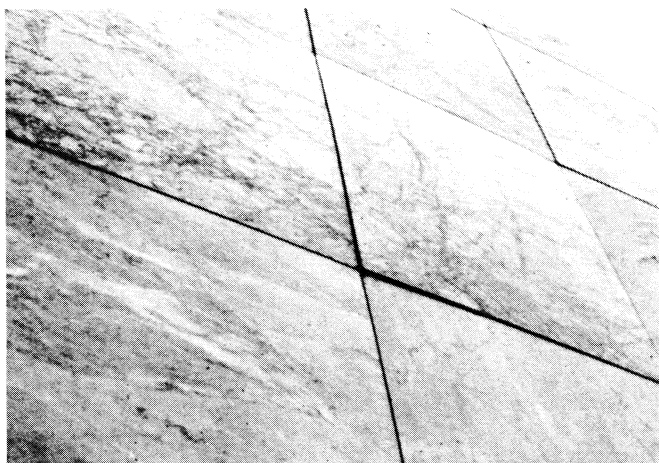
Fig. 3-4 - View of outward displacement of marble panels.

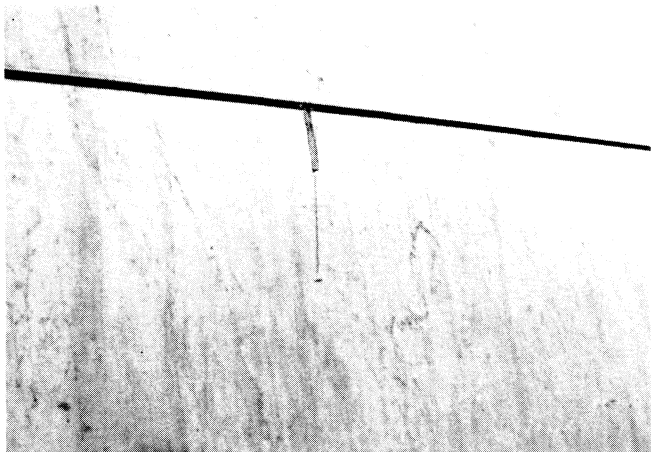
4. Elongation of some of the cracks in the panels that were previously repaired by Amoco, as typically shown in Fig. 3-5.

Fig. 3-5 - View of a previously repaired crack that increased in length.

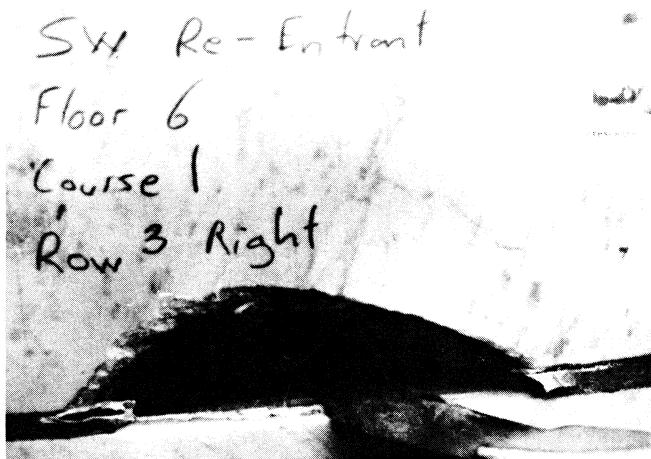
Between 1979 and 1985, the number of panels with this type of cracking had increased by approximately 2,560 panels or by approximately 1,100 percent, as shown in Table 3-3. This type of cracking included panels with new, fine, vertical cracks at the connections that were observed for the first time by WJE in 1985. When these cracks were lightly tapped with a hammer they formed crescent shaped cracks, as shown in Fig. 3-6.

Fig. 3-6 - View of crescent shaped crack and fracture that occurred in marble panels after fine, vertical cracks in the panels at connections were lightly tapped.

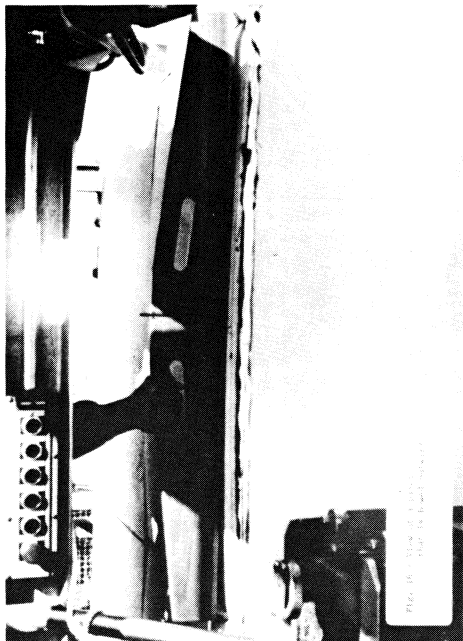
Fig. 3-7 -

Between 1979 and 1985, the maximum bow in the panels increased by approximately 5/8 in. or by approximately 200 percent. The observed outward bowing of the panel was actually an outward dishing of the panels because the bow occurs along both the vertical and horizontal axis of the panels. Approximately 80 percent of the significantly bowed panels were located on the south and east elevations of the building, which unlike the west elevation, have no adjacent structures to block direct exposure to the sun. The marble panels on the north elevation of the building had the least amount of outward bowing.

Marbles primarily consist of calcite crystals. Calcite crystals are anisotropic. This means that when they are heated the crystals expand in different amounts in different directions, and when they are subsequently cooled, they cannot return to their original position because the crystals interlock. This phenomenon is called hysteresis, and it often results in a permanent expansion in the marble and an accompanying strength loss. Hysteresis also often causes marble panels to dish when one of the faces of the panels is heated to a higher temperature than the other, thus causing the side exposed to the higher

View of a marble panel that is bowed outward.

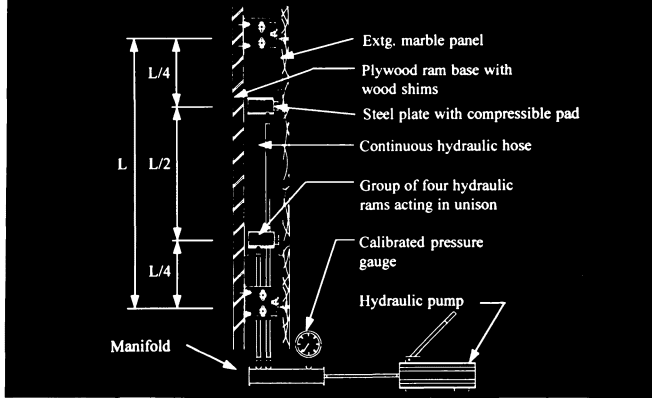
1. The typical marble panels tested failed at equivalent negative uniform wind loads that varied from 45 psf to 100 psf.

2. Forty-four, or about 92 percent of the 48 marble panels tested, failed at their kerf connections. All but one of these 44 panels failed at their bottom connection suggesting that the sealant in the kerf at the top of the panels added strength to the connection.

Fig. 3-9 - Set-up on insitu load test of marble panels.

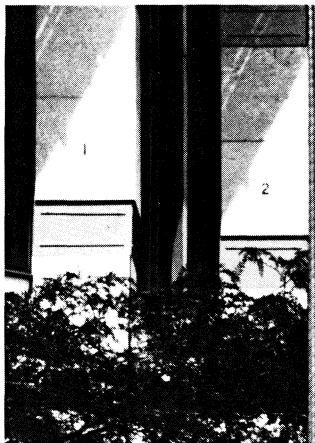
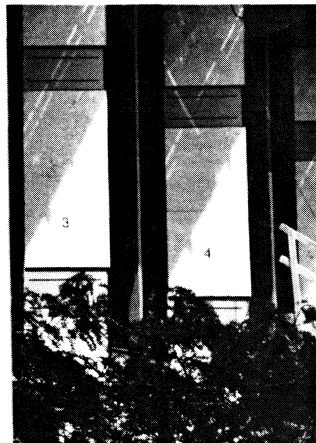
**Fig. 9-2 - Condition of granite panels and sealants in test panel on April 11, 1964. Note discoloration of silicone sealants and staining of granite panels by silicone sealants.**

**Fig. 9-2 - View of sealant test panel after 18 months of outside exposure. Note staining of stone by silicone sealants and dirt accumulation on silicone sealants.**

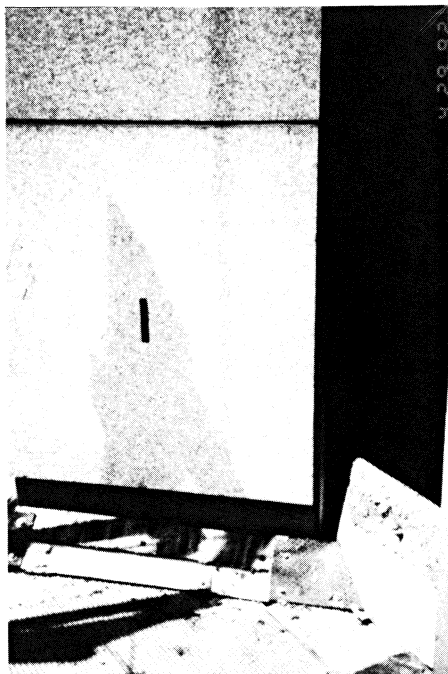
**Fig. 9-4 - Typical view of staining of granite adjacent to joints sealed with silicone sealants.**
